HOME INSPECTION REPORT

30 Golden Hill, catonsville, MD 21228

Wednesday June 14, 2017

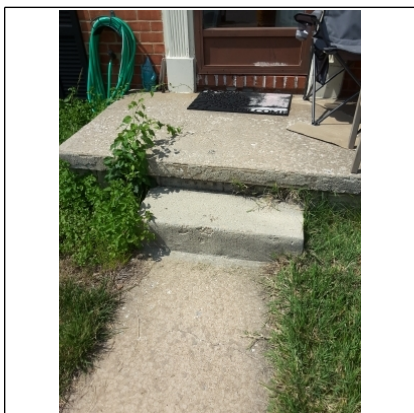
Condition Satisfactory Cracked

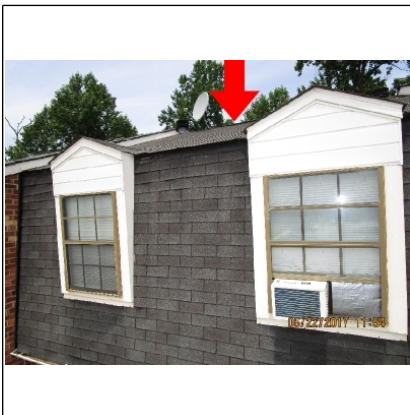
Roof #1 Satisfactory Granules missing

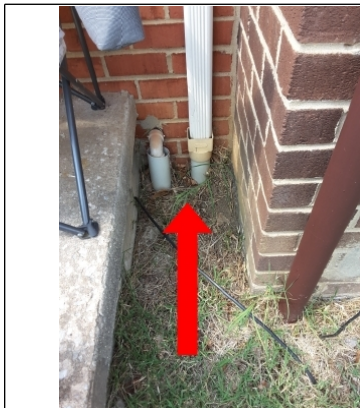
Gutter run-off into ground drain

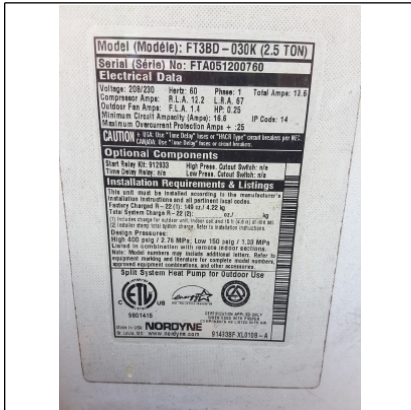
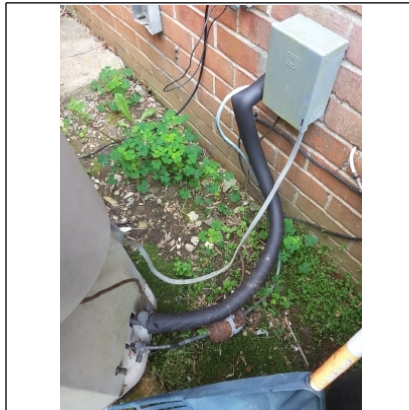
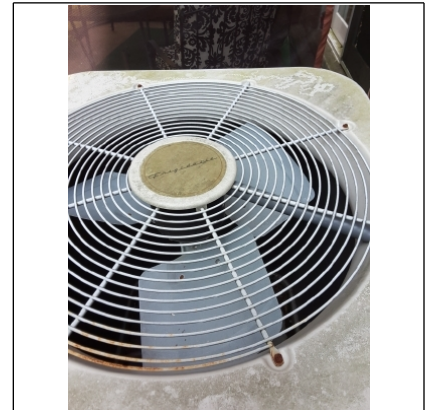
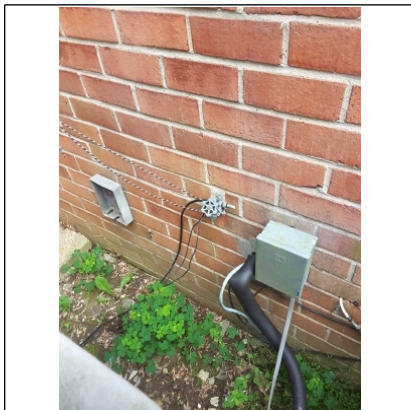
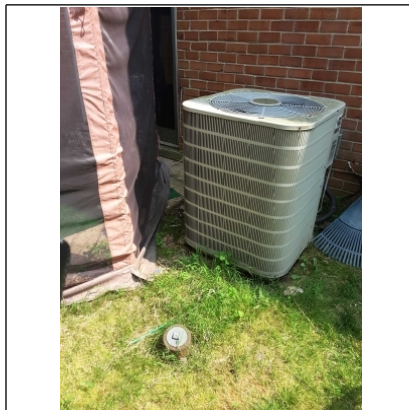
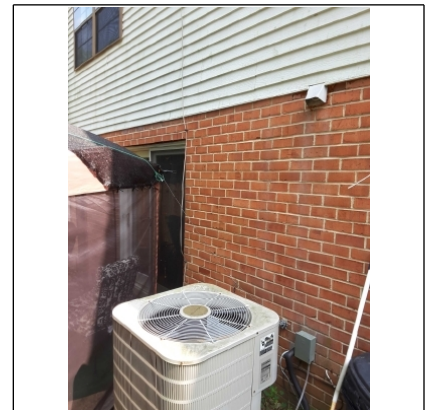
Comments Outside condenser unit coils dirty recommend cleaning

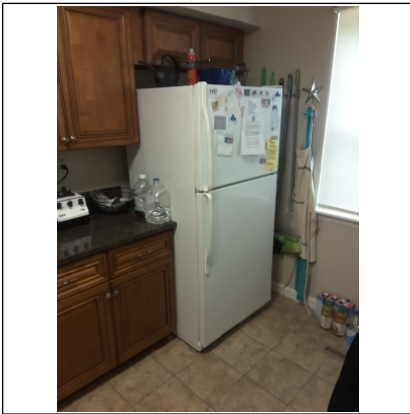
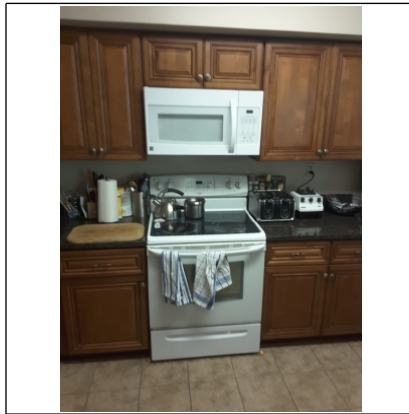
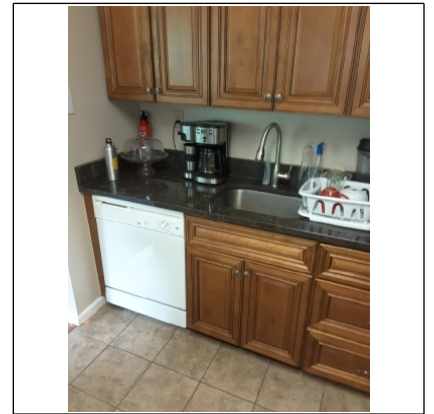
Comments Appliances only tested for operation, working or not. Quality or extent of operation not part of testing or inspection
Refrigerator/freezer door gasket needs replacing.
Microwave does not heat properly, recommend repair

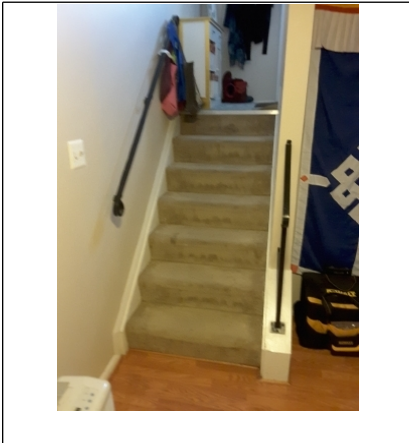
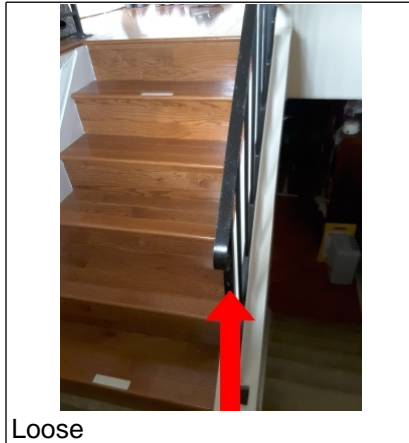
Comments Handrail loose, potential safety hazard. Recommend securing/repair

Loose

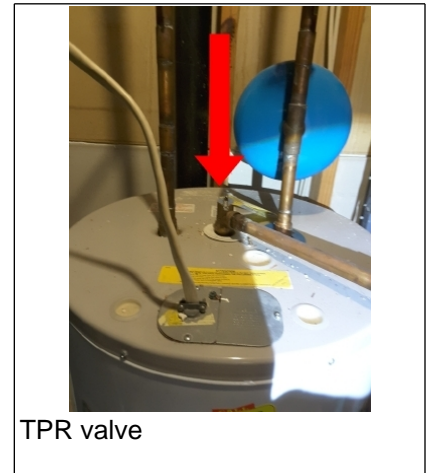
Comments Temperature-Pressure relief valve extension should be 4"-6" off of the floor - this is a Safety Concern.

Pressure release pipe
Extends into ground exit plumbing

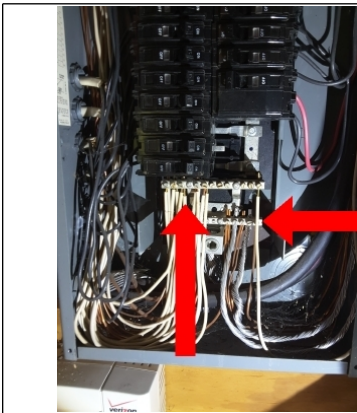
10 Double taps
Safety hazard
Recommend electrical evaluation

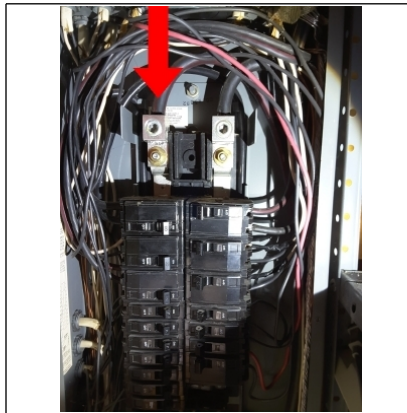
Comments Panel size appeared to be compatible to service size.
No signs of overheating were evident at the time of the inspection.
Outlets were randomly tested and had correct polarity, except as noted.
Main wires are aluminum - recommend no-oxidation paste be applied to wires to prevent corrosion
Panel cover was missing some screws recommend adding proper screws to secure panel cover

Aluminum wiring service entrance

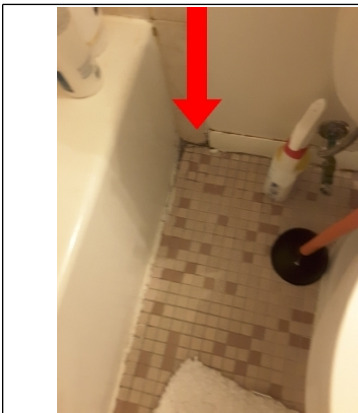
Comments Recommend caulking/grouting in shower/tub area
Damaged floors around tub / shower, recommend repair
Damaged floor around toilet bowl, recommend repair

Recommend ceramic repair
