HOME INSPECTION REPORT

30 Golden Hill, catonsville, MD 21228

Wednesday June 14, 2017

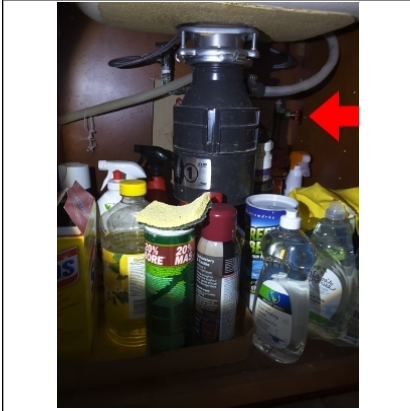
Comments Water flow was normal with several fixtures operated at the same time.
There were no visible active piping leaks at the time of the inspection.
There were some plumbing connections with some dissimilar metals monitor for leaks
Some minor corrosion around the joints, but no visible leaks at this time.
Drain lines had no visible leaks or signs of backup at the time of inspection.
