HOME INSPECTION REPORT

30 Golden Hill, catonsville, MD 21228

Wednesday June 14, 2017

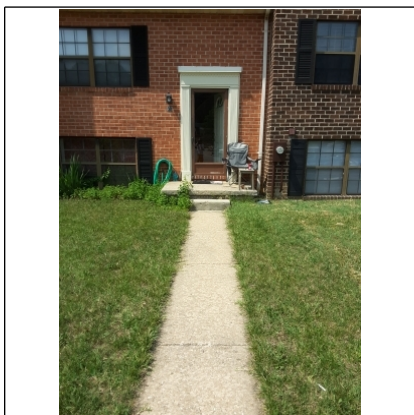
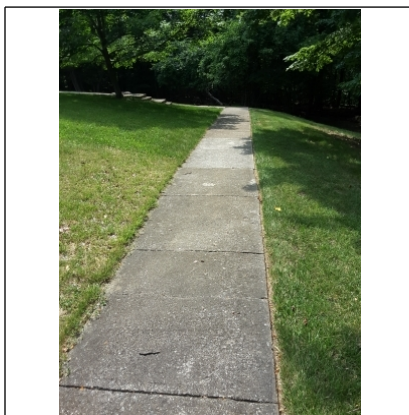
Service Walks

Material Concrete

Condition Satisfactory

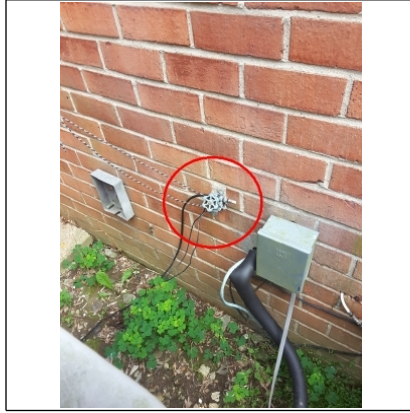
Hose bibs

Condition Satisfactory No anti-siphon valve Recommend Anti-siphon valve

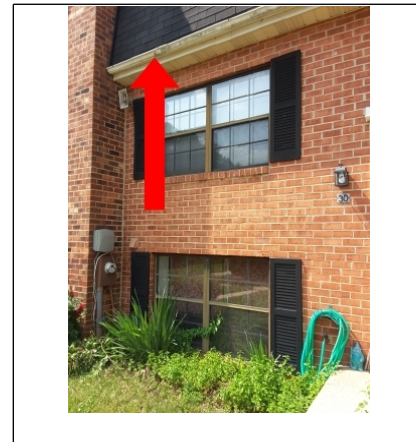
Gutter run-off into ground drain

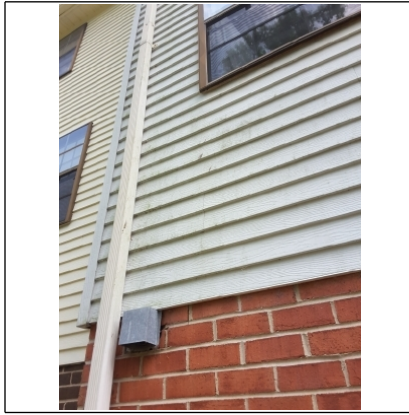
- Material Block/Brick Metal/Vinyl
- Condition Satisfactory
- Comments Siding appeared to be all intact and in overall satisfactory condition.
Brick and mortar appeared to be in overall adequate condition.
Caulking appeared to be in overall adequate condition.

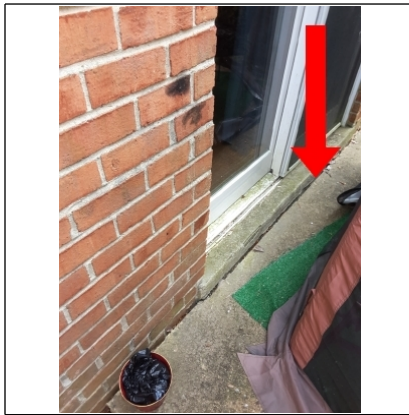
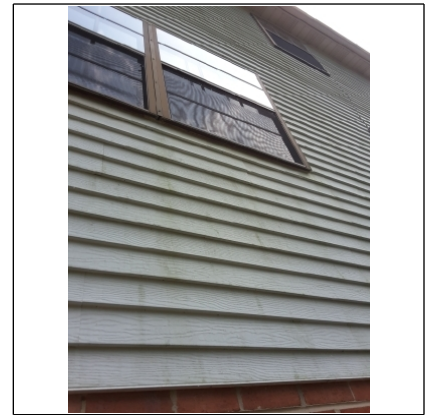
Caulking

Condition Satisfactory Recommend around windows/doors/masonry ledges/corners/utility penetrations

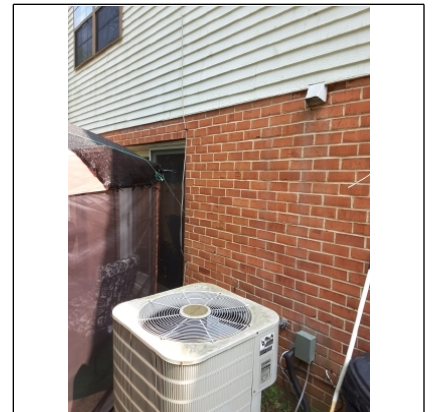
Building(s) Exterior Wall Construction

Comments Building structure not visible due to siding, not evaluated.

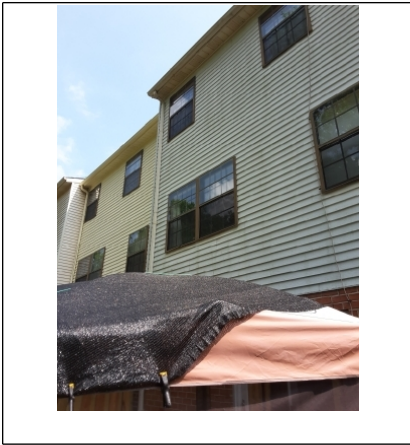
Non functional

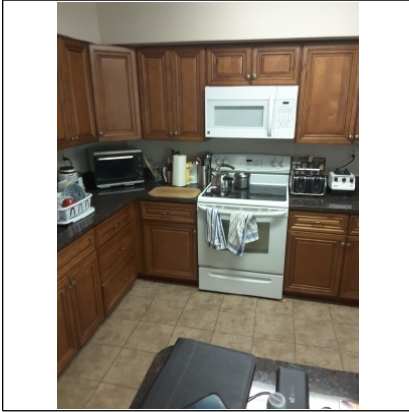
Comments Counter top has normal wear.

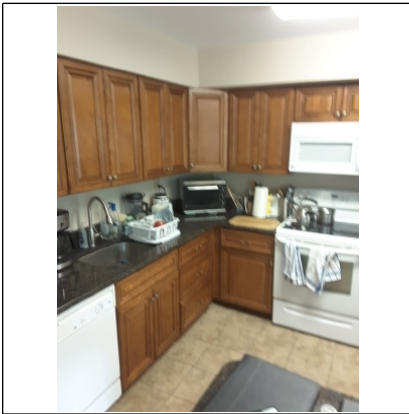
Comments Cabinets have normal wear.

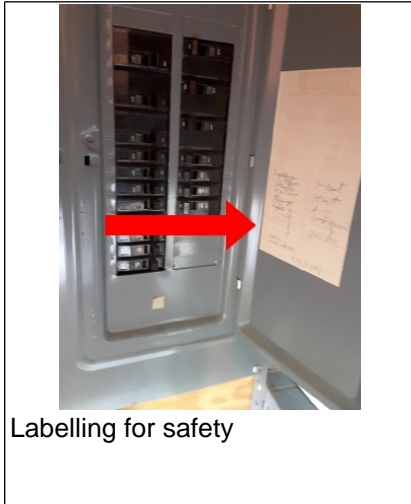
Electric/Cooling System (1)

Labelling for safety
